July 15, 2020

Subject: Asbestos Survey Letter Report
Lorraine W. Bills School
217 North Washington Street
Herkimer, New York
HRP Project Number: HER1500.P2 Task 08
Brownfields Assessment Cooperative Agreement: BF-96261019-0

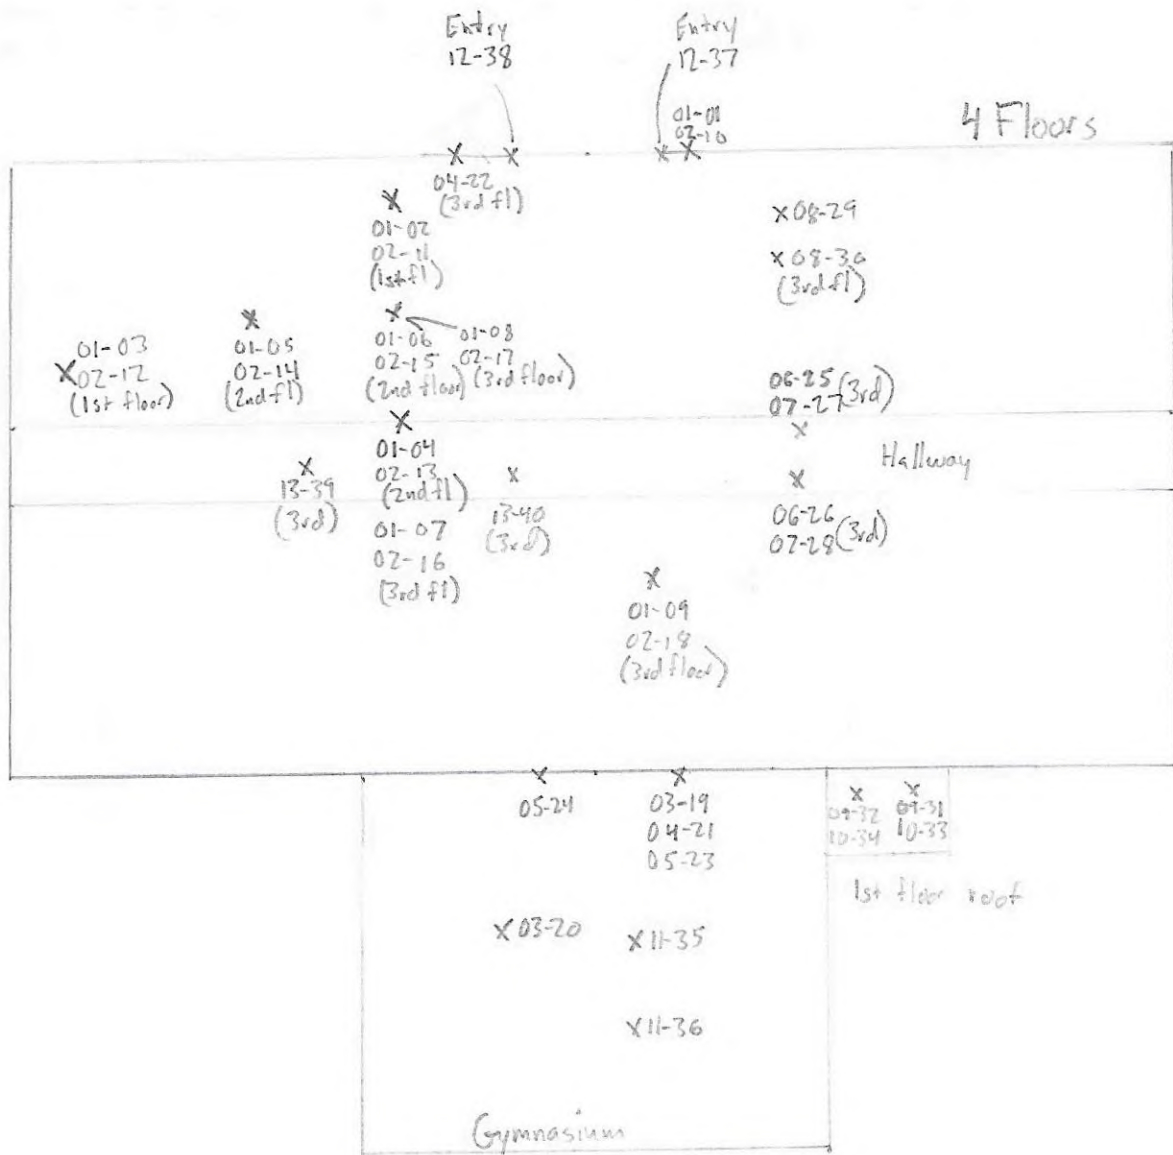
Bills School Sampling Locations

Sample #	Location	Description of Material	Total % Asbestos	Estimated Quantity	Condition of Material
05-23	Gym Roof	Black Flashing	5.4% Chrysotile	~1,000 linear feet	Good/Non Friable
08-29	Classroom #25, 3 rd Floor	Gray 9x9 Vinyl Floor Tile	4.5% Chrysotile	~4,000 square feet	Significantly Damaged/Friable
12-37	Exterior Front Entry Between Stones	Gray Mortar	6% Chrysotile	~800 linear feet	Fair/Friable
NA	Boiler Room	Boiler Room Not Accessible as Basement Was Flooded	Unknown, Possible TEM	Unknown	NA
NA	Main Roof	No Access, Assumed Positive	Possible	15,000 ft ²	NA
